THEMATIC MAPPER

(E83-10259) THEMATIC MAPPER FLIGHT MODEL
PRESHIPMENT REVIEW DATA PACKAGE, VOLUME 2,
PART B: SUBSYSTEM DATA (Santa Barbara
Research Center) 287 p HC A13/MF A01

FLIGHT MODEL
PRESHIPMENT REVIEW
DATA PACKAGE
VOLUME II - SUBSYSTEM DATA
PART B
Article IV - 3A

HUGHES AIRCRAFT COMPANY
SPACE AND COMMUNICATIONS GROUP

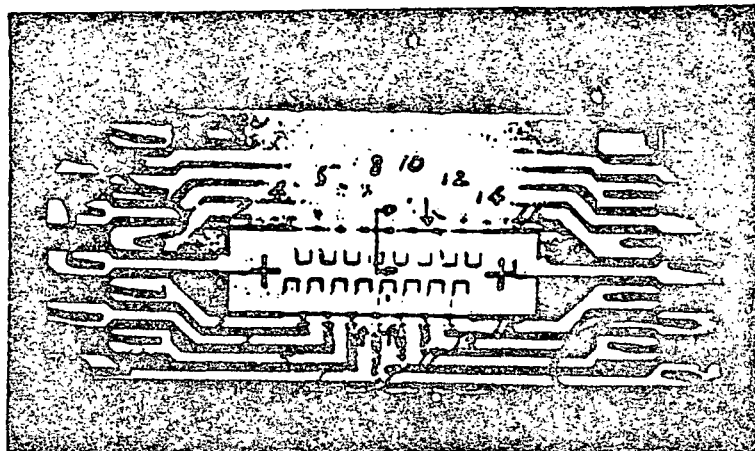
Several photovoltaic InSb detector chips were submitted to TSD for failure analysis. Several diodes (channels) out of sixteen in each chip had been shorted or degraded, without any visible change in their microscopic appearance. (Figure 1 shows the overall layout of the chip.) SBRC strongly suspected that the degraded performance of these diodes was due to electrostatic damage (ESD). [Ref: SBRC Internal Memo HS236-7391, dated 12 March 1981.]

FIGURE NO. 1. - Band 7, chip layout and numbering system. This thin-oxide region, containing the diodes, is in the inner rectangle. The section line marks the typical cross-section of Figure 2. The actual size of the central rectangle is about .375 x 1.36 mm.

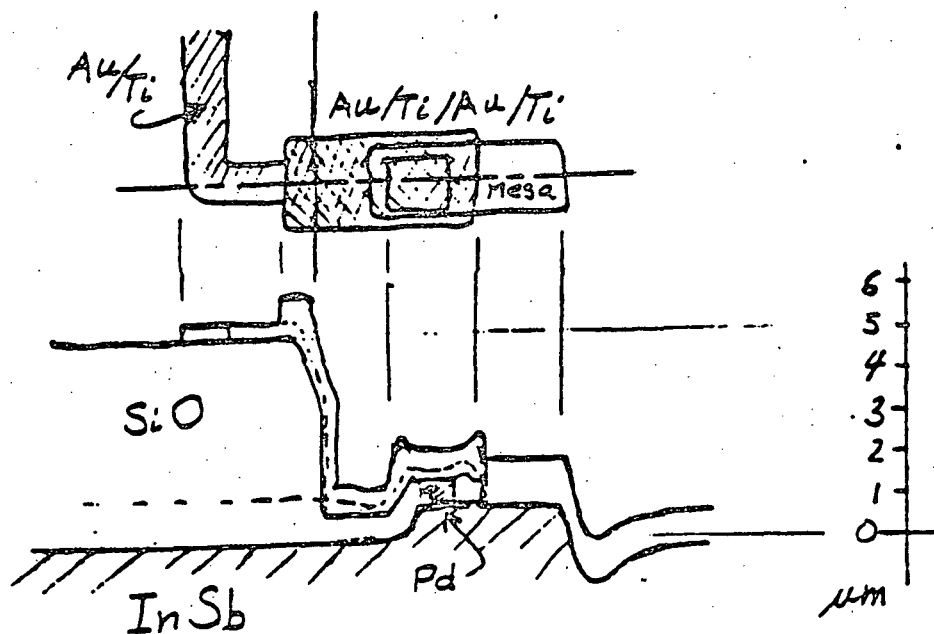
In Figure 2, an index of 1.9 was assumed for SiO_2 , and used for thickness in the central region. For the thick oxide areas, it was possible to check this value using several chipped areas near the edge where the InSb substrate was exposed. There was good agreement with measurements of the step height.

FIGURE NO. 2. - IR Detectors - Coating structure from interferometry.

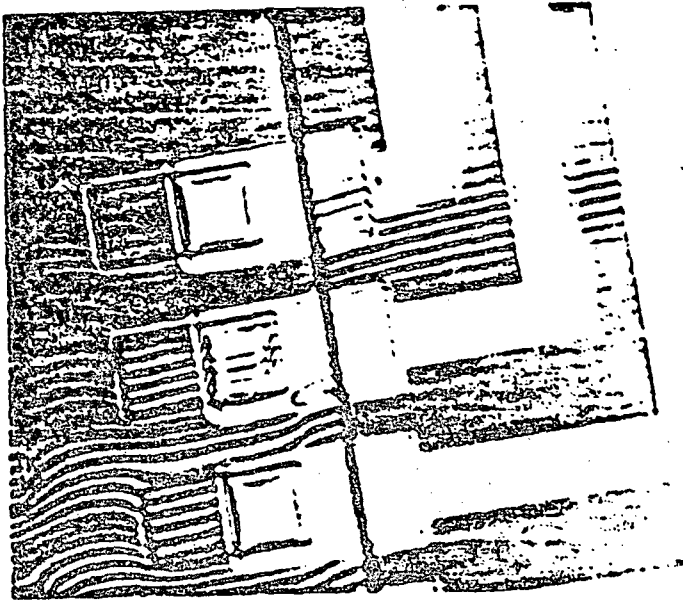
FIGURE NO. 18

The measurements in this work were made using a Watson Interference Objective adapted to a Reichert microscope. Other companies make instruments very convenient for shop use in evaluating surface finishes or scratch depths. Figure 18 shows a typical micro-interferogram used in making measurements for Figure 2. The fringes are at intervals of $.29 \mu\text{m}$ (a half-wave of yellow light).

A white-light interferogram on the as-received Band 7 chip. In the thin oxide at left, two fringe systems can be seen, from the oxide surface and one from the oxide/substrate interface.

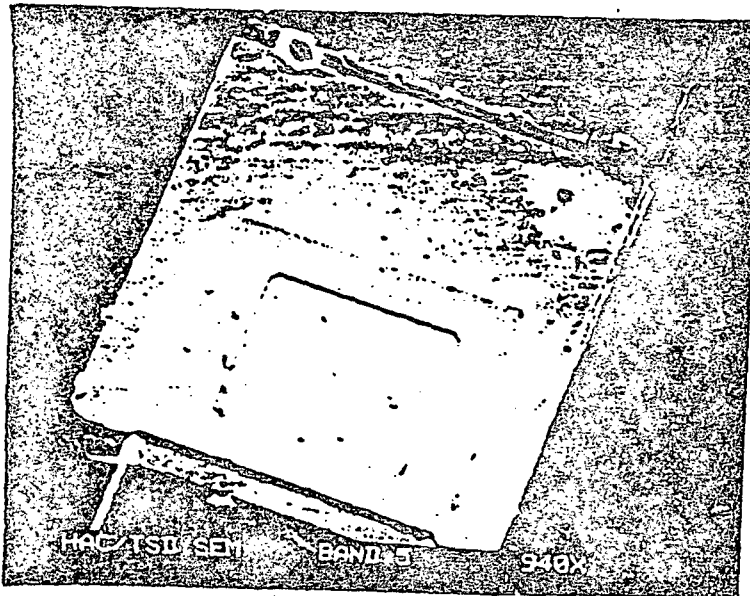
FIGURE NO. 19

Following the usual practice for silicon IC's, attempts were made to strip metallization with chemical etchants. Figure 19 shows a typical diode after removal of the external gold layers with a potassium-iodide solution. Small amounts of gold remain in several areas, while the oxide is completely untouched. The intermediate titanium protects the inner gold layer in the thick-metallization area. The inner gold could not be removed until an application of "Sapp etch" penetrated the titanium.

SEM of typical diode after 45 seconds KI etch. Lighter granular material is residual gold. Remaining exposed metal is Ti; thicker area is Ti/Au/Ti sandwich.
